## MAINTENANCE SPECIFICATIONS

Model Type - CF6-80E1A4

Serial No. 811207

ESN:	811207	POSITION:	RH	ENG TYPE:	CF6-80E1A4	DATE:	17 April 2020
A/C MODEL:	A330-200	A/C MSN:	510	REG.#	F-OJSE	REASON:	CONDITIONAL INSPECTION
JOB SITE:	Ascent Aviation, Marana, Arizona, USA				WORK ORDER:	WO-04-20-1575

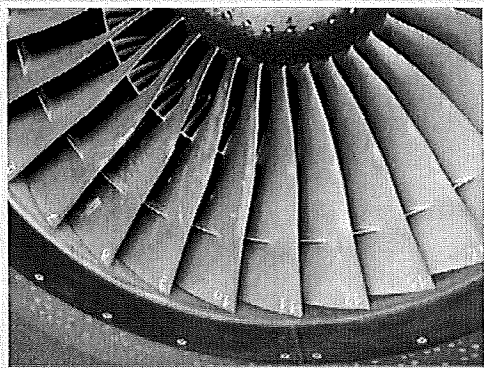
LPC Fan	No significant discrepancies noted. Some leading edge erosion observed.	
Inspected:		
Yes		
Serviceable:		
Yes

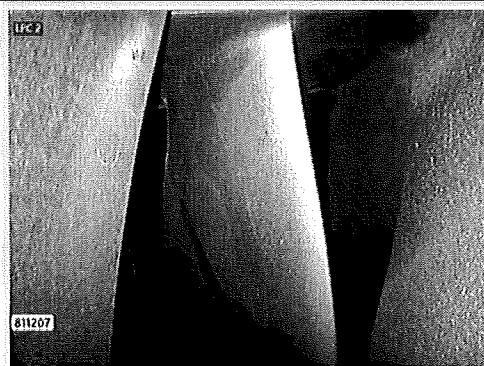
LPC Stage 2	No significant discrepancies noted. Leading edge erosion and atmospheric buildup observed.	
Inspected:		
Yes		
Serviceable:		
Yes

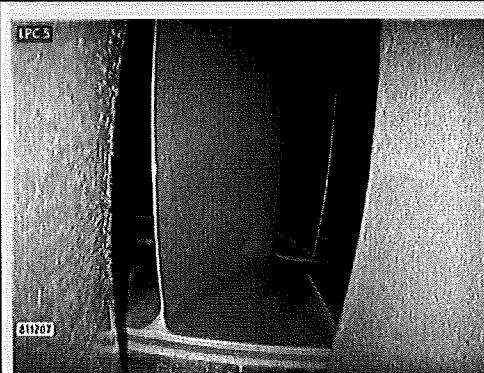
LPC Stage 5	No significant discrepancies noted at this time.	
Inspected:		
Yes		
Serviceable:		
Yes

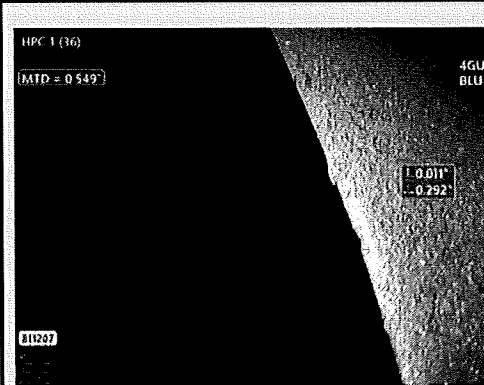
HPC Stage 1	Some minor leading edge impacts observed that were measured and verified to be within AMM limits. <b>ACCEPT</b> Per A330 AMM Chap. 72-00-00 Pg. 49 attached for reference.	
Inspected:		
Yes		
Serviceable:		
Yes

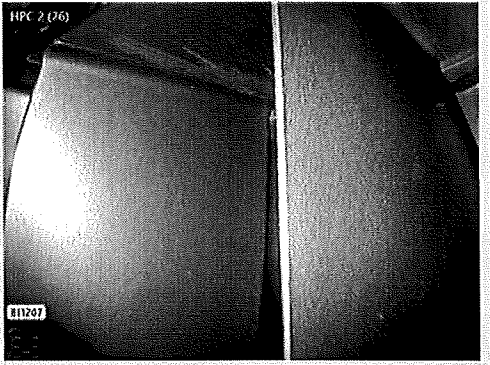
High Pressure Stage:	Comments	
HPC Stage 2	No significant discrepancies noted at this time.

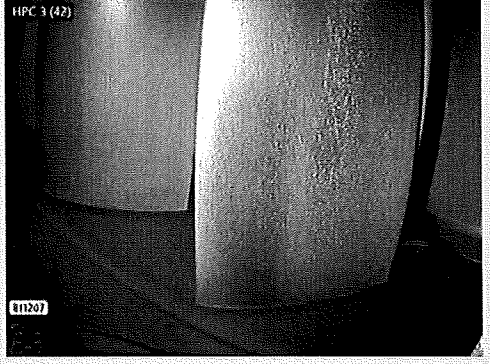
High Pressure Stage:	Comments	
HPC Stage 3	Some leading edge erosion and environmental buildup observed. No significant discrepancies noted at this time.

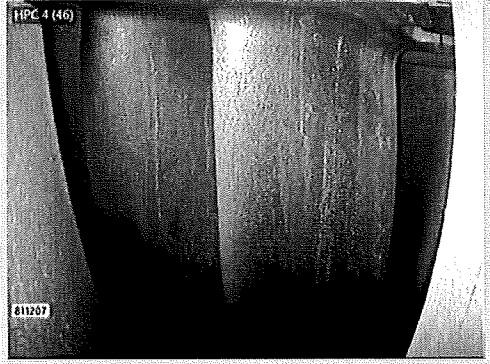
High Pressure Stage:	Comments	
HPC Stage 4	No significant discrepancies noted at this time. Some atmospheric deposit observed.

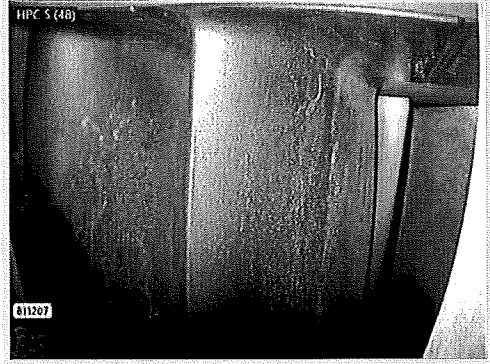
High Pressure Stage:	Comments	
HPC Stage 5	No significant discrepancies noted at this time. Some atmospheric deposit observed.

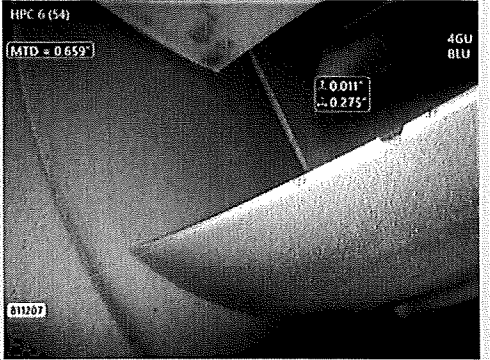
High Pressure Stage:	Comments	
HPC Stage 6	Some minor leading edge impacts observed that were measured and verified to be within AMM limits. <b>ACCEPT</b> Per A330 AMM Chap. 72-00-00 Pg. 49 attached for reference.

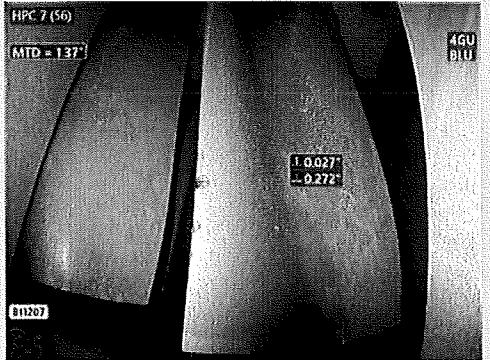
High Pressure Stage:	Comments	
HPC Stage 7	Some minor leading edge impacts observed that were measured and verified to be within AMM limits. <b>ACCEPT</b> Per A330 AMM Chap. 72-00-00 Pg. 49 attached for reference.

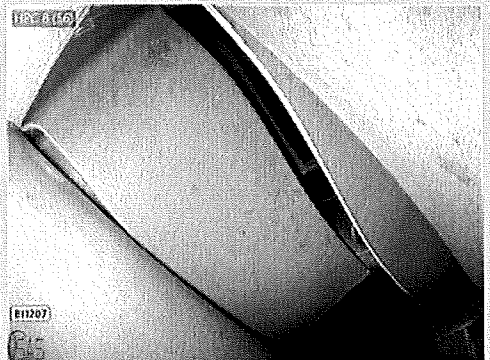
High Pressure Stage:	Comments	
HPC Stage 8	No significant discrepancies noted at this time.

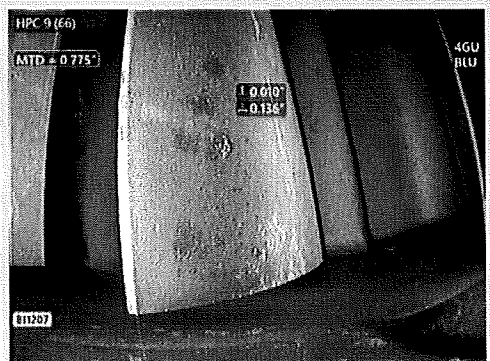
High Pressure Stage:	Comments	
HPC Stage 9	Some minor leading edge impacts observed that were measured and verified to be within AMM limits. <b>ACCEPT</b> Per A330 AMM Chap. 72-00-00 Pg. 49 attached for reference.

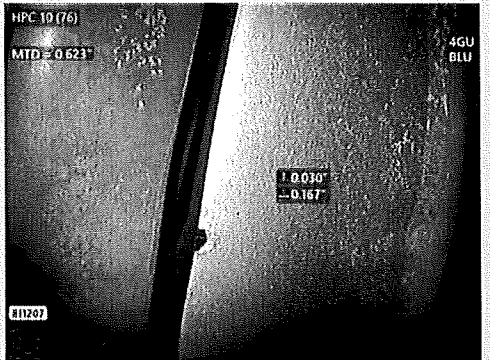
High Pressure Stage:	Comments	
HPC Stage 10	Some minor leading edge impacts observed that were measured and verified to be within AMM limits. <b>ACCEPT</b> Per A330 AMM Chap. 72-00-00 Pg. 49 attached for reference.

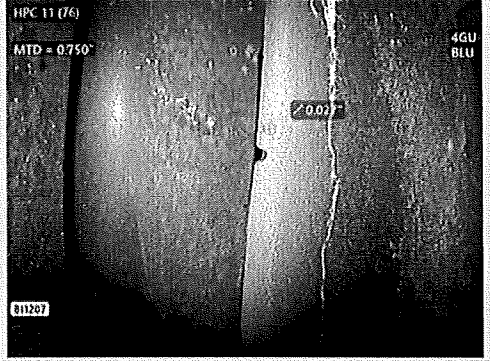
High Pressure Stage:	Comments	
HPC Stage 11	Some minor leading edge impacts observed that were measured and verified to be within AMM limits. <b>ACCEPT</b> Per A330 AMM Chap. 72-00-00 Pg. 49 attached for reference.

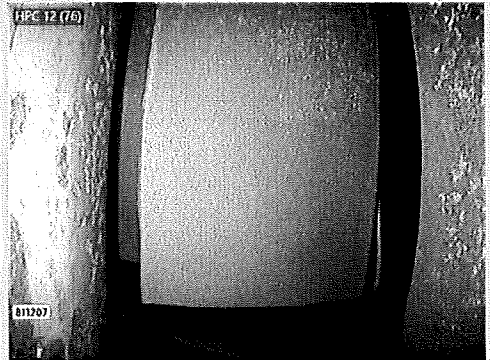
High Pressure Stage:	Comments	
HPC Stage 12	No significant discrepancies noted at this time. Some previous shop blends observed.

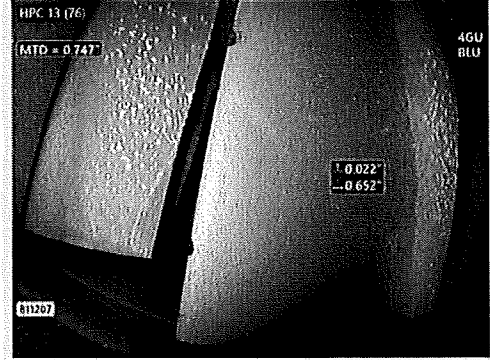
High Pressure Stage:	Comments	
HPC Stage 13	Some minor leading edge impacts observed that were measured and verified to be within AMM limits. <b>ACCEPT</b> Per A330 AMM Chap. 72-00-00 Pg. 49 attached for reference.

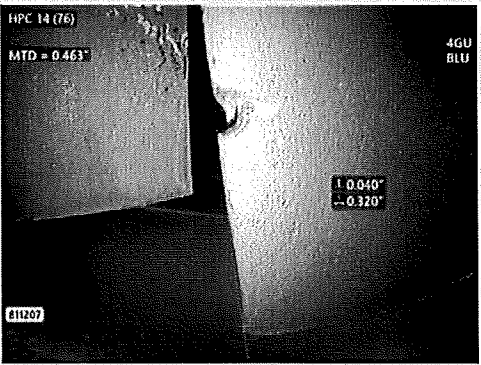
High Pressure Stage:	Comments	
HPC Stage 14	Some minor leading edge impacts observed. Few blades (less than 6) were observed to have some nicks with displaced material and a small associate tear within .500" of the blade tip. All defects were verified to be within AMM limits. <b>ACCEPT</b> Per A330 AMM Chap. 72-00-00 Pg. 49 attached for reference.

Stages	Condition	Notes	Maximum Serviceable Limits
1-2, 4-9	Tears, nicks, cracks, missing material and dents on the leading and trailing edges.	*[1], *[2], *[3], *[4]	All nicks, missing material and dents are permitted if not more than 0.05 in. (1.27 mm) in depth, and the blade is not torn or bent. Torn or cracked edges are not permitted.
3	Tears, nicks, cracks, missing material and dents on the leading and trailing edges.	*[1], *[3], *[4]	No damage permitted in outer 2 in. (50.80 mm) of blade. For the rest of the blade, all other limits apply.
END OF POST GE SB 72-156			
10-12	Tears, nicks, cracks, missing material and dents on the leading and trailing edges.	*[3], *[4]	If the damage is less than 0.30 in. (7.62 mm) from the tip: all nicks, missing material and dents are permitted if not more than 0.05 in. (1.27 mm) in depth. The blade must not be torn, cracked or bent. Nicks, dents and missing material less than 0.12 in. (3.05 mm) in depth, or cracks and tears less than 0.12 in. (3.05 mm) in length are permitted if no more than six blades in each stage are damaged. If the damage is more than 0.299 in. (7.59 mm) from the tip: Any number of nicks, missing material and dents up to 0.0499 in. (1.27 mm) maximum depth are serviceable. The blade must not be torn or bent. Torn or cracked edges greater than 0.299 in. (7.59 mm) from the tip are not serviceable.

END OF PRE GE SB 72-156			
12-14	Cracks	*[1]	The cracks must be in a radial direction along the tip of the blade.
13-14	Nicks, dents and missing material on the leading and the trailing edges.	*[3]	Permitted, if less than 0.05 in. (1.27 mm) in depth.
13-14	Nicks, dents, missing material, tears and cracks on the leading and trailing edges, less than or equal to 0.5 in. (12.70 mm) from the blade tip.	*[3]	A maximum of six blades per stage are permitted, if less than 0.120 in. (3.05 mm) in depth.
13-14	Tears, cracks and bends on the leading and trailing edges, greater than 0.50 in. (12.70 mm) from the blade tip.	*[3]	Not permitted.

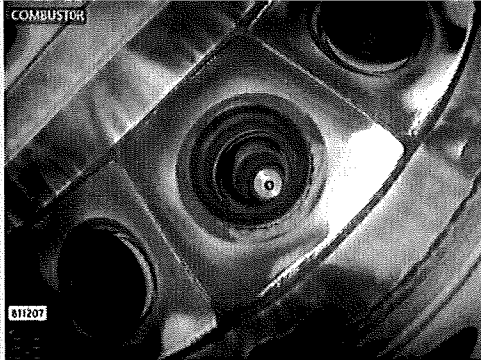
Combustor:	Comments	
Bulkhead, Deflectors and Fuel Nozzles	Some light surface and coating erosion observed to splash plate and dome area. <b>ACCEPT</b> Per A330 AMM Chap. 72-00-00 Pg. 70 attached for reference.

INSPECT/CHECK	MAXIMUM SERVICEABLE LIMITS	REMARK
Discoloration	Any amount permitted.	
Carbon accumulation	Any amount permitted.	
Missing, chipped or spalled areas of the thermal barrier coating	Any amount permitted.	
Dome plate radial cracks in the cooling holes area	Any amount permitted if they do not connect with other cracks.	See the continue-in-service limits (Ref. AMM TASK 72-00-00-200-831) .
Inner and outer region of dome plate radial cracks	Any amount permitted if they do not connect with other cracks.	See the continue-in-service limits (Ref. AMM TASK 72-00-00-200-831) .
Dome plate circumferential cracks in the cooling holes area	Any amount permitted if less than 0.50 in. (12.70 mm) in length. Up to two cracks permitted if they are less than 1 in. (25.40 mm) in length and there is 2.5 in. (63.50 mm) or more between the cracks.	See the continue-in-service limits (Ref. AMM TASK 72-00-00-200-831) .

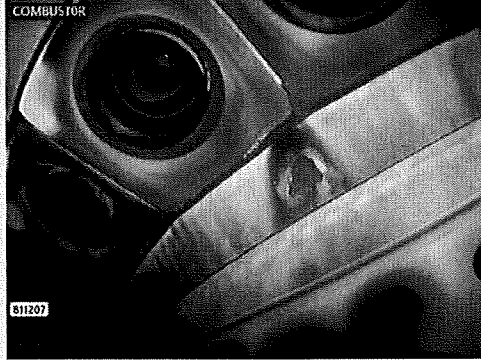
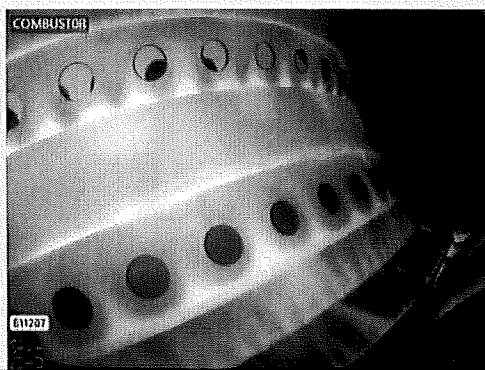
Combustor:	Comments	
Inner and Outer Liners	Some light surface discoloration observed. <b>ACCEPT</b> Per A330 AMM Chap. 72-00-00 Pg. 71 attached for reference.

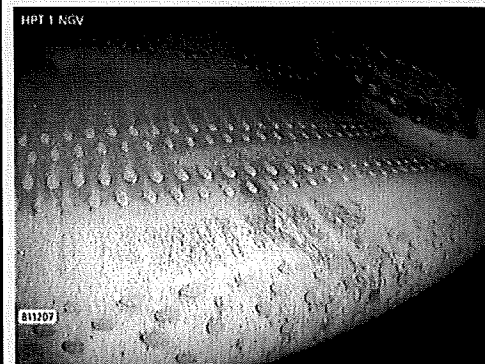
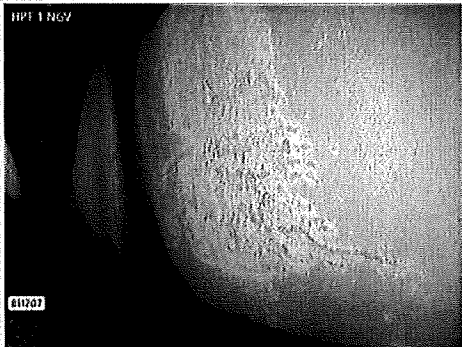
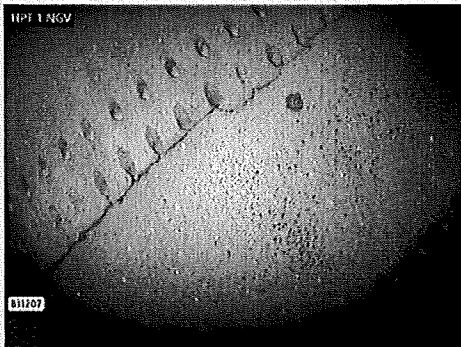
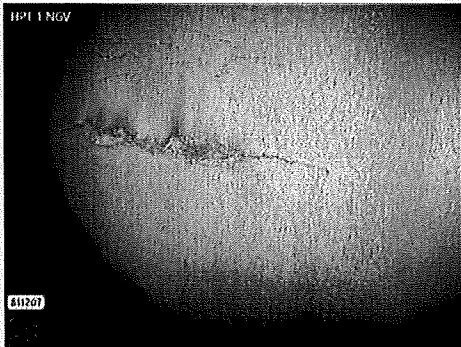
High Pressure Turbine:	Comments	
HPT1 NGV	Several vanes observed with tight leading edge cracks, concave side radial cracks, convex cracking and burning, and trailing edge burns. Some cracking observed to the platforms that has no associated missing material. All findings were verified to be within AMM limits. <b>ACCEPT</b> Per A330 AMM Chap. 72-00-00 Pg. 215, Pg. 216, and Pg. 217 attached for reference.

INSPECT/CHECK	MAXIMUM SERVICEABLE LIMITS	REMARK
1. Inspect the leading edge of the vane airfoil for:		
A. Cracks interconnecting nose holes	Any number if no material is gone. See for maximum serviceable extension.	
B. Cracks propagating from nose holes, but not interconnecting nose holes	Any number if no material is gone. See maximum serviceable extension.	
C. Burns or erosion	Permitted if the maximum loss of material or burns (that are fully through the metal) are not more than 0.3 in.2 (194.0 mm2) for each vane. A maximum of four vanes in a 90 degree arc can have this damage. If adjacent vanes have damage, replace the three fuel nozzles that are upstream of the damaged area within the next 100 flight cycles. See maximum serviceable extension.

2.Concave surface of vane airfoil for:		
A.Radial cracks out of the gill holes	Any number; no missing material. See maximum service extension.	
B.Other cracks (not in the gill holes rows)	Any number no missing material. See maximum service extension.	
C.Burns	Any number no missing material or burn through. See maximum service extension.	
D.Cracks in fillet area adjacent to inner and outer platforms	Any number no missing material. See maximum service extension.	
E.Maximum service extension for 1st stage HPT nozzle vane:		
Convex surface missing material from cracking or burn-through up to 0.5 in.2 (322.58 mm2) per airfoil	25 cycles.

3.Convex surface of vane airfoil for:		
A.Radial cracks	Any number no missing material. See maximum service extension.	
B.Axial cracks	Any number no missing material. See maximum service extension.	
C.Burns	Any number no missing material or burn through. See maximum service extension.	
D.Cracks in fillet area adjacent to inner and outer platforms	Any number no missing material. See maximum service extension.	
E.Maximum service extension for 1st stage HPT nozzle vane:		
Concave surface missing material from cracking or burn-through up to 0.5 in.2 (322.58 mm2) per airfoil	25 cycles.

4.Trailing edge of vane airfoil for:		
A.Axial cracks originating from slots adjacent to trailing edge	Any number.	
B.Buckling or bowing	Any amount.	
C.Burns, tears or dents (loss of metal)	Total area removed from trailing edge not to exceed 6 in.2 (3870.96 mm2) per assembly, 1.5 in.2 (967.74 mm2) per airfoil. See maximum service extensions.	
D.Maximum service extension for 1st stage HPT nozzle vane:		
Trailing edge missing material from cracking or burn-through up to 2.5 in.2 (1612.90 mm2) per air-	25 cycles.

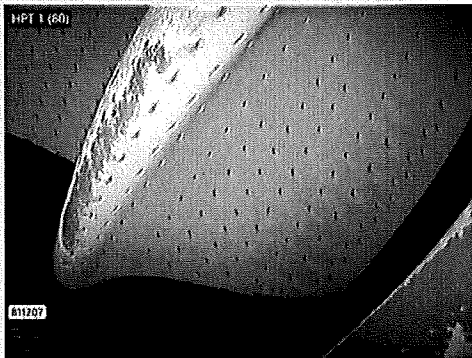
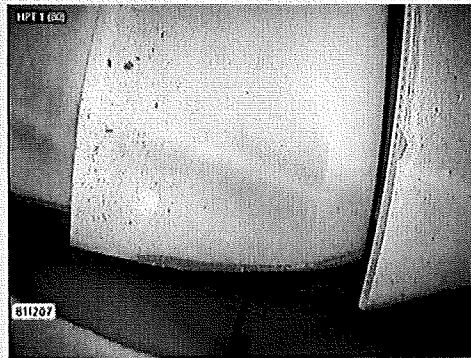
High Pressure Turbine:	Comments	
HPT1 Blades	Several blades observed with TBC (Thermal Barrier Coating) loss and erosion. <b>ACCEPT</b> Per A330 AMM Chap. 72-00-00 Pg. 93 attached for reference.

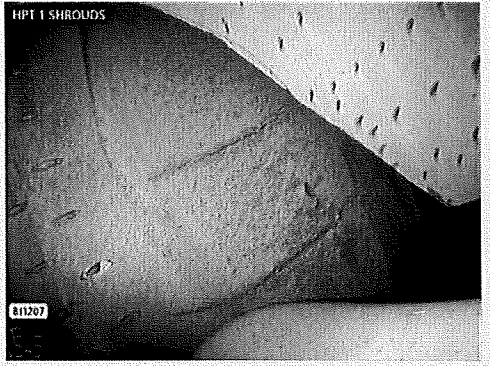
High Pressure Turbine:	Comments	
HPT1 Shrouds	Numerous axial cracks observed on several shrouds. This condition is acceptable in any amount. <b>ACCEPT</b> Per A330 AMM Chap. 72-00-00 Pg. 217 attached for reference.

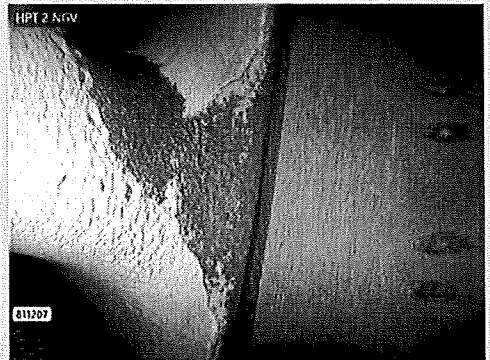
High Pressure Turbine:		
HPT2 NGV's	Numerous vanes observed with TBC (Thermal Barrier Coating) erosion. Some tight cracks observed along the platform mating faces. Some cracks were observed around the borescope port. These cracks are considered to be outer platform cracks between the vanes. All of these cracks measured less than .150" in length and are therefore acceptable in any number. <b>ACCEPT</b> Per A330 AMM Chap. 72-00-00 Pg. 219 attached for reference.

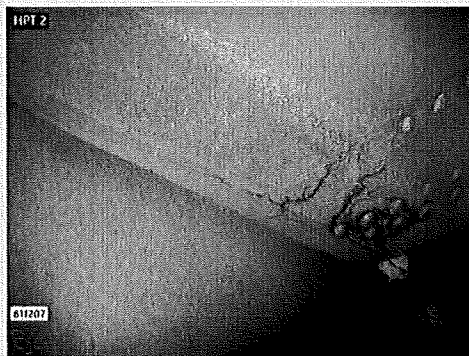
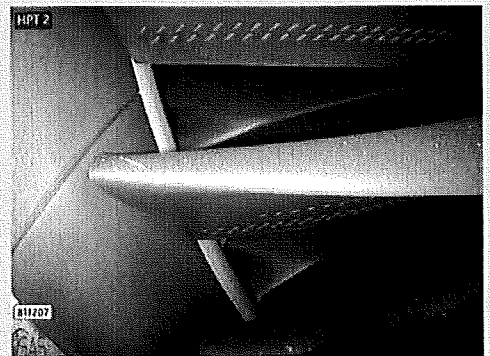
High Pressure Turbine:	Comments
HPT2 Blades	No significant discrepancies noted. Some previous tip repairs and surface stains observed.
Inspected:	
Yes	
Serviceable:	
Yes

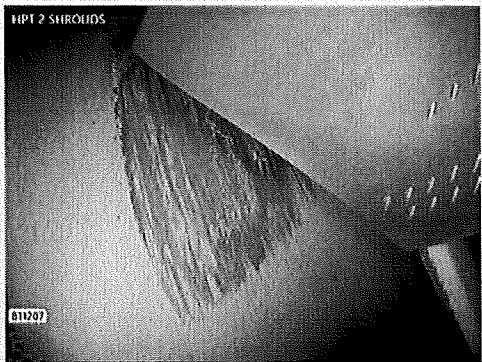
HPT2 Shrouds	Some light surface rub observed. No significant discrepancies noted at this time.	
Inspected:		
Yes		
Serviceable:		
Yes

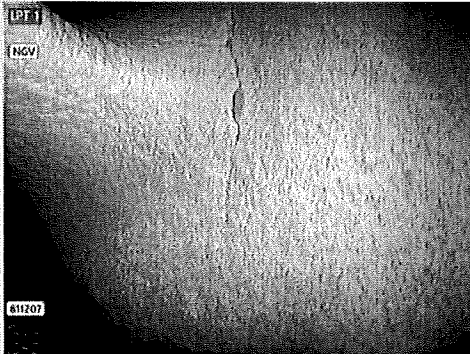
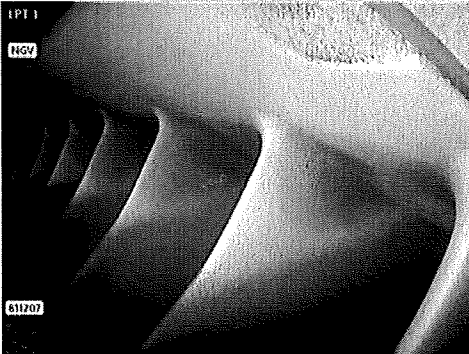
Low Pressure Turbine:	Comments	
LPT Stage 1 NGV	Numerous vanes observed with tight coating/ craze cracks on the platform and near the leading edge fillet radius. No significant defects or parent material damage observed.	
Inspected:		
Yes		
Serviceable:		
Yes

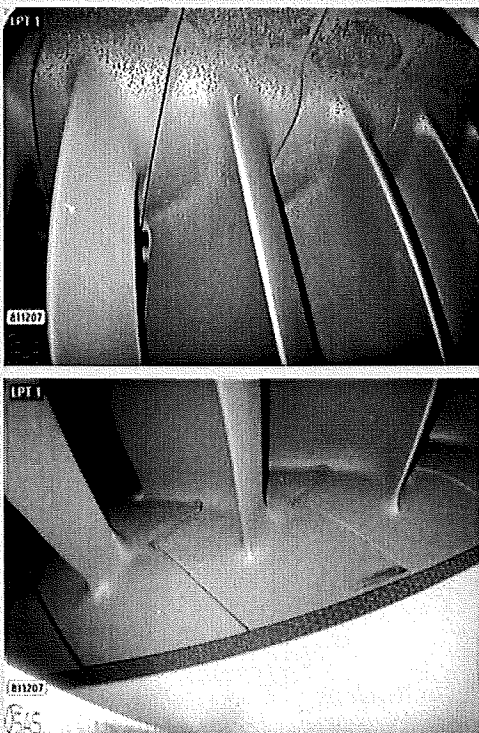
LPT Stage 1 Blades	Some coating discoloration observed. Some rubs observed to the top surface of the seal lip. All rubbed areas were less than 50% of their respective seal lips. <b>ACCEPT</b> Per A330 AMM Chap. 72-00-00 Pg. 113 attached for reference.	
Inspected:		
Yes		
Serviceable:		
Yes

7. Inspect the seal lips for: Typical Low Pressure Turbine Rotor Blade Inspection SHEET 1		
A. Rubs, turned or missing material	Any amount up to 50 percent of seal lip.

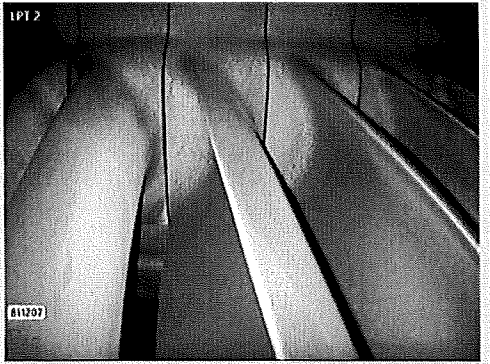
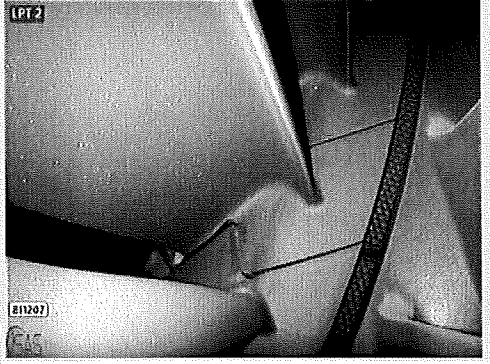
Low Pressure Turbine:	Comments	
LPT Stage 2 Blades	No significant discrepancies noted at this time.

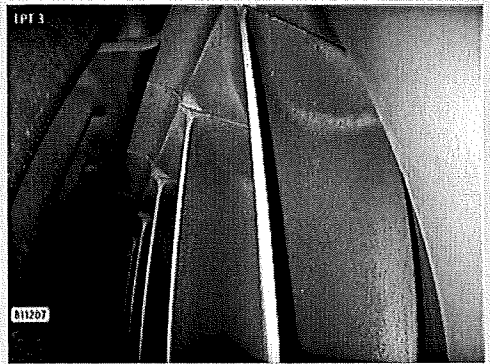
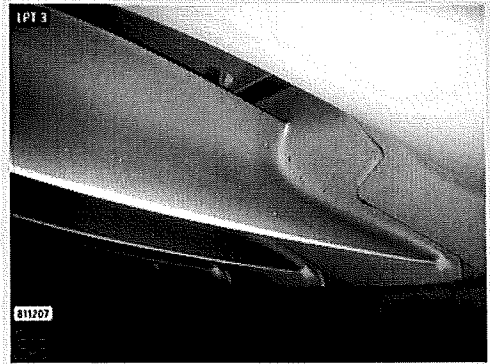
Low Pressure Turbine:	Comments	
LPT Stage 3 Blades	No significant discrepancies noted at this time.

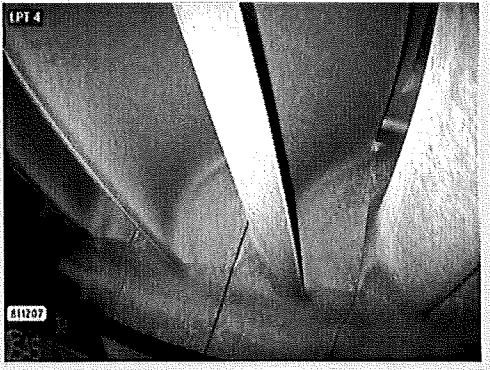
Low Pressure Turbine:	Comments	
LPT Stage 4 Blades	No significant discrepancies noted at this time. Some coating discoloration and environmental deposit observed.

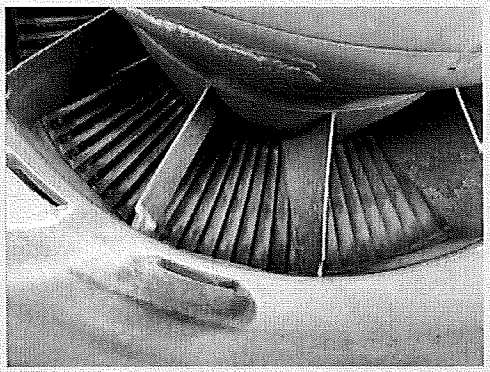
Low Pressure Turbine:	Comments	
LPT Stage 5 Blades	No significant discrepancies noted as viewed from the exhaust.
